# Manhole Inspection Summary

Manhole # S13KK\_006MH

Insp Date: **7/24/09 12:21 PM**

**Location** Address: **2101 DUKELAND ST**

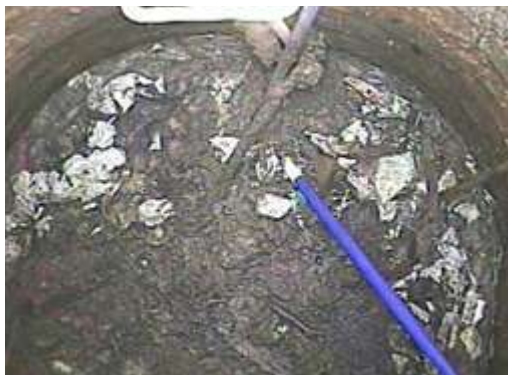
Defect 1

ACTIVE SLUDGE SURCHARGE

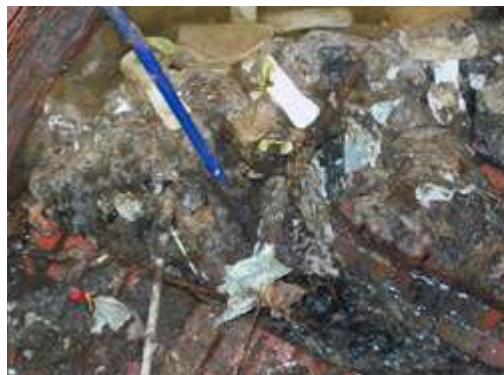
Defect 5

DEBRIS IN CHANNEL AND PIPE

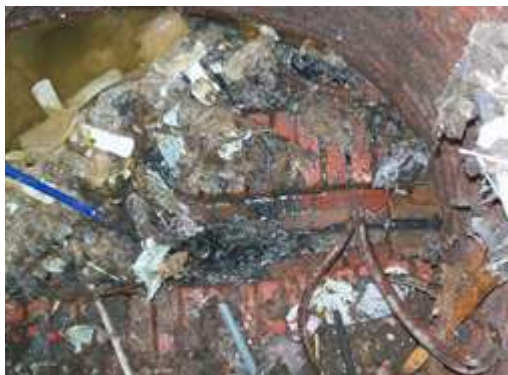
Defect 4

DEBRIS ON BENCH

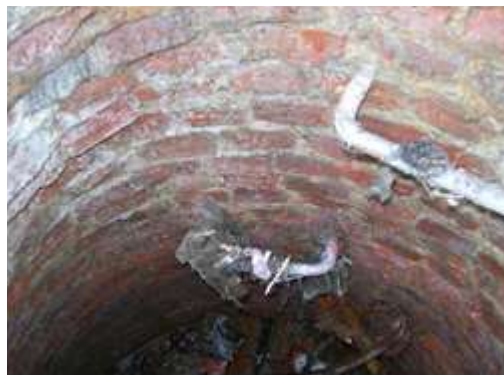
Defect 3

**Surcharge** ☒ **Evidence Of Surcharge** Depth: **1.8** (ft.) ☐ Active Surcharge Present

EVIDENCE SURCHARGE

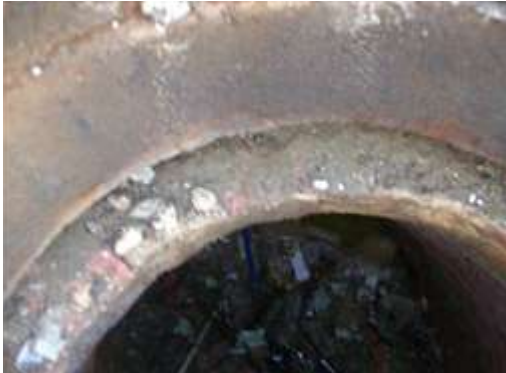
Defect 2

OFFSET

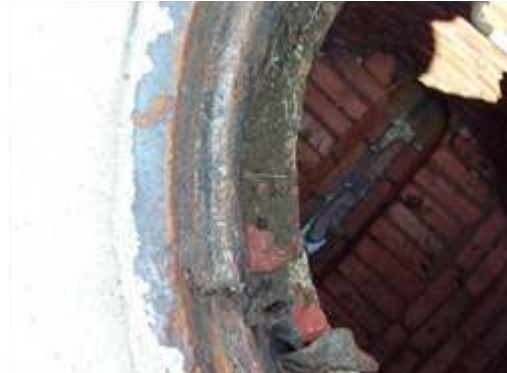
Defect 9

**Frame** Offset: **3** (in.) Condition: ☒ Sound ☐ Cracked ☐ Leaks

FRAME OFFSET 2"

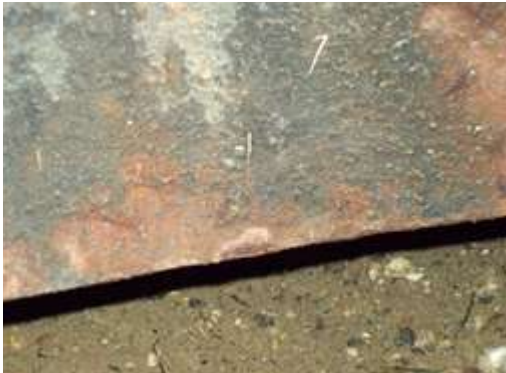
Defect 8

Condition: ☐ Sound ☐ Cracked ☐ Root Intrusion ☐ Loose Brick ☒ **Deteriorated**

GAP BELOW FRAME DETERIORATED

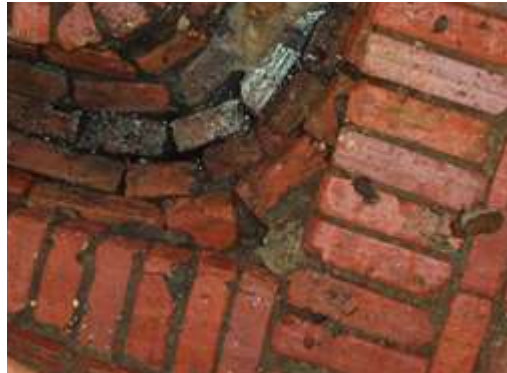
Defect 6

Condition: ☐ Sound ☐ Cracked ☐ Root Intrusion ☒ **Deteriorated** ☐ Leaks ☐ Debris

DETERIORATION OF CHANNEL

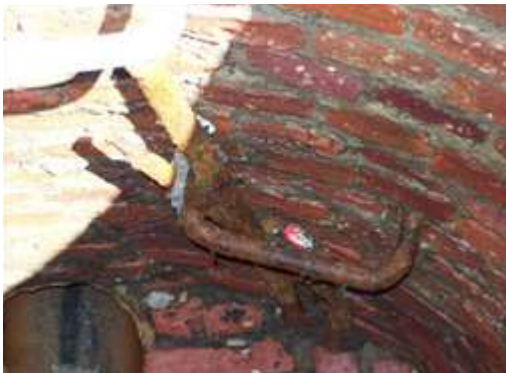
Defect 7

**Steps** Count: **3** Missing: **0** ☒ **Corroded**

DEBRIS ON BENCH. CORRODED STEP

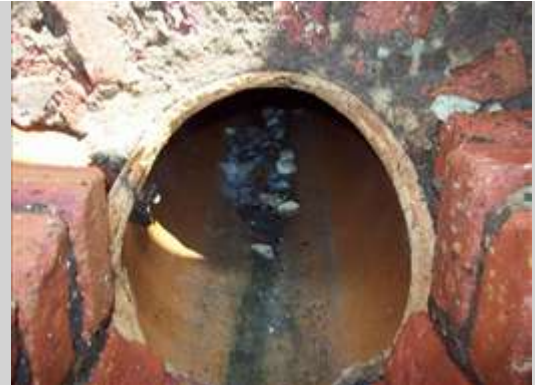
12 O'Clock Outflow

ROCKS IN PIPE

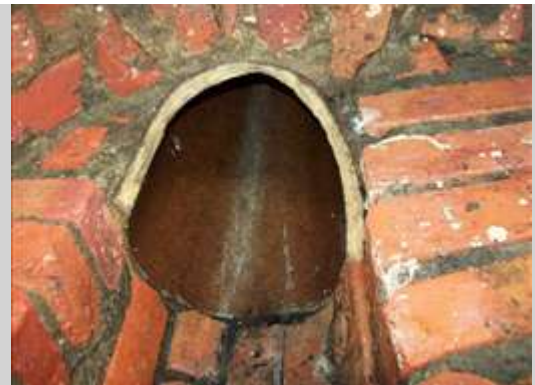
8 O'Clock Inflow

Silt Depth: **8** (in.) Deposits Extent: **Heavy**
